TERRA
ENGINEERING LTD.

CITY OF WELDON SPRING

“BACK” WOLFRUM ROAD SAFETY STUDY

December 14, 2023

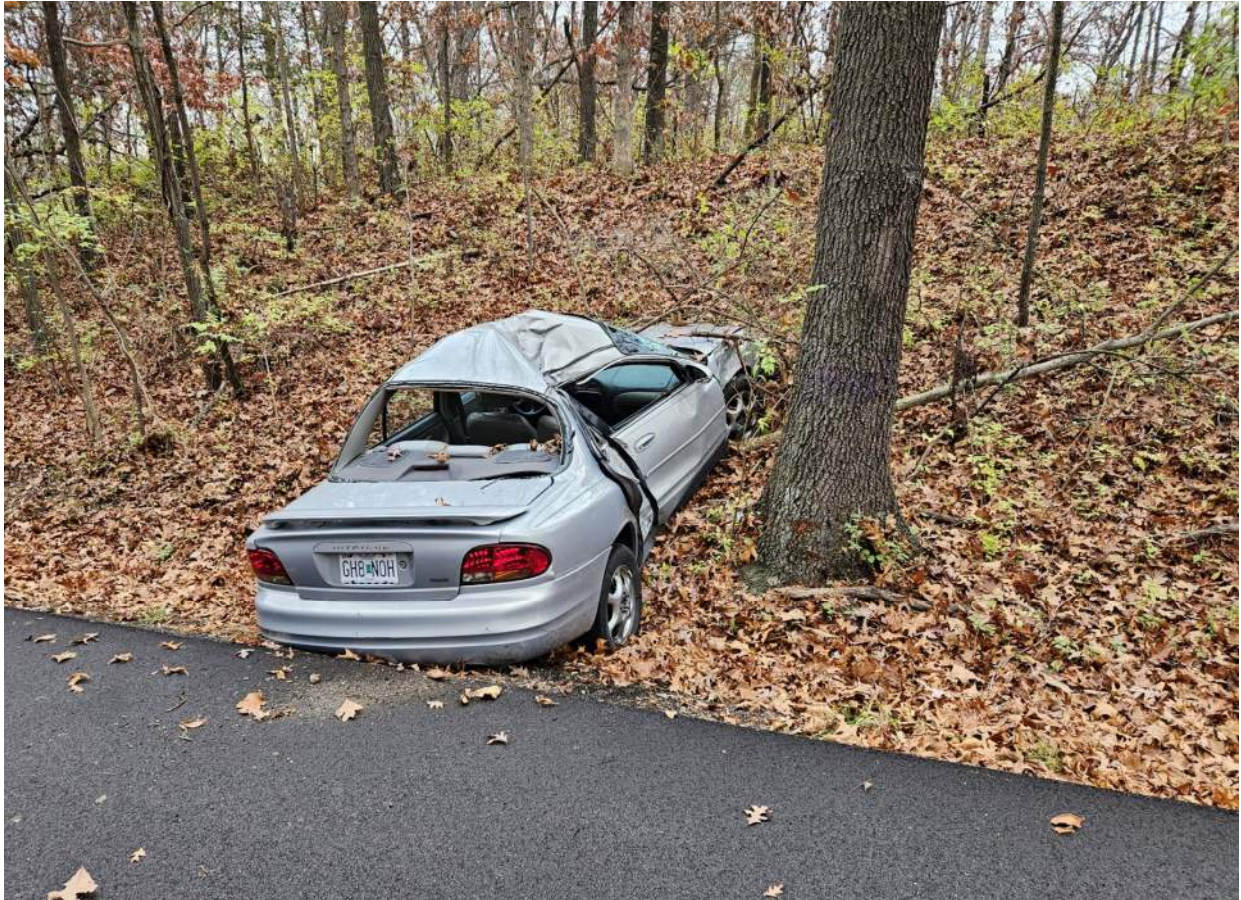
It is important to note again that if the police are not contacted then no report is filed, and it would not be reported within the website, therefore the expected crashes which occurred is likely higher than reported. As an example of crashes not being reported, the City of Weldon Spring staff discovered an abandoned car located along the side of Wolfrum Road on November 17, 2023. TERRA staff ran a new query on the MSHP website in December 2023 and there were no reported crashes listed on the website, however this car was significantly disabled and not able to be driven from the site. A photo of this crash is provided in Figure 13.

Figure 13 - Unreported Crash on November 17, 2023.

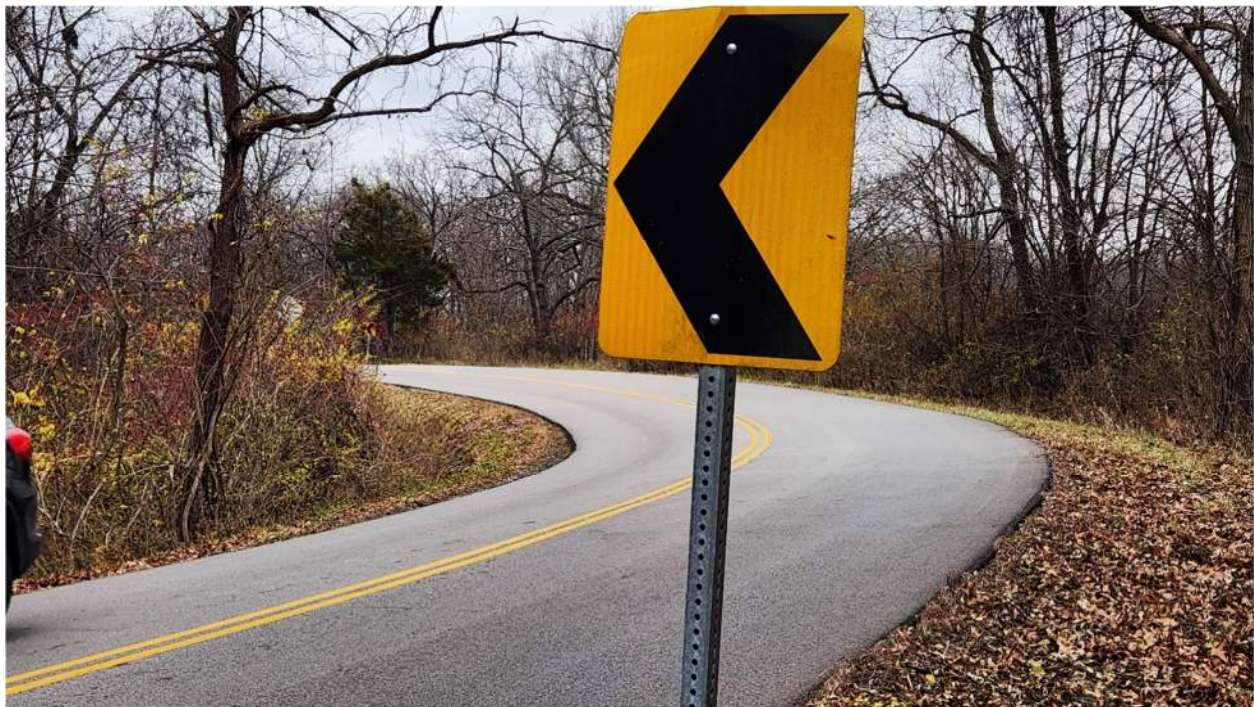
Working from west to east along Wolfrum Road the first location of concern is on the curve located just west of Wolfrum Road and Patriotic Trail there are several chevron signs (W1-8) in place to denote the curvature in the roadway, however there are two at the beginning of the curve and then a large gap in the signs before reaching the final chevron. This gap is either due to poor sign placement or could be because signs were hit by cars leaving the roadway surface and are no longer in place. As shown in Figure 14 there is a chevron sign in the foreground but then a large gap to the next sign in the background of the picture.

Figure 14 - View along westbound Wolfrum Road approaching Patriotic Trail.

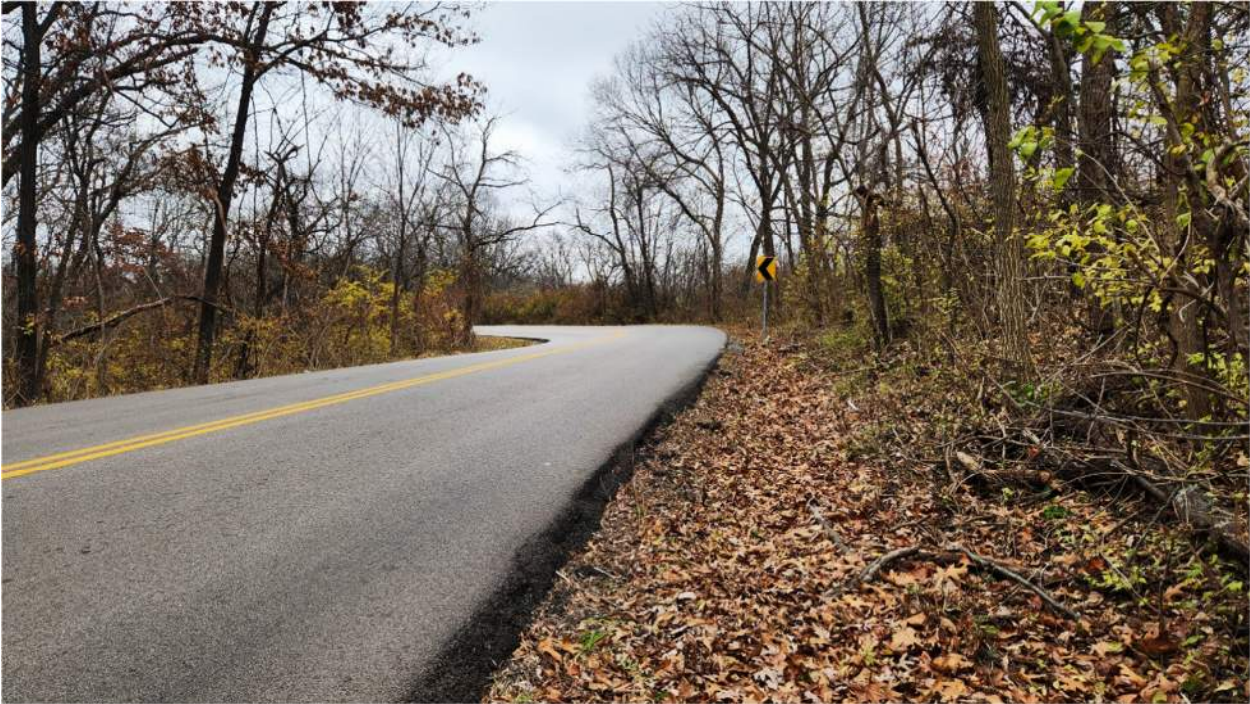
Panning back and looking at the foreground chevron from further away in Figure 16, it is clear that additional chevrons are needed to delineate the curvature in the roadway.

Figure 16 - Another picture approaching the curve traveling westbound.

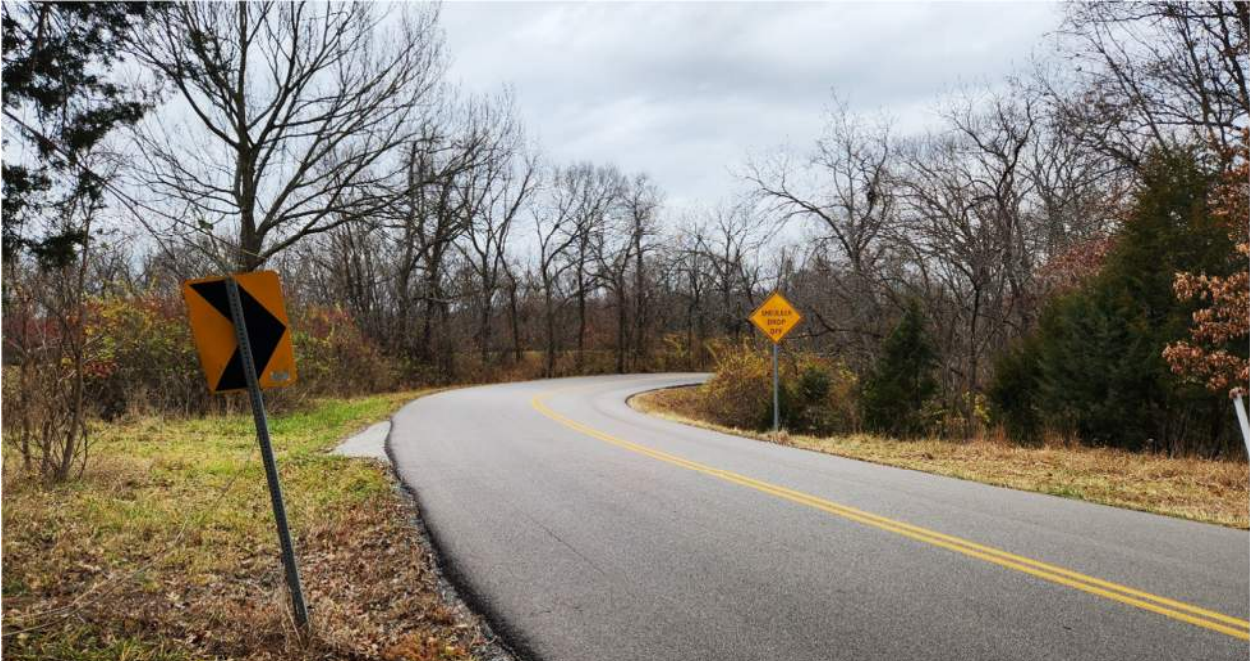
Figure 17 - Back of westbound facing chevron.

Another thing noted at this curve location is that the chevrons are single sided with the signs only facing westbound and no chevrons providing guidance for eastbound traffic. As noted in Figure 17 the post blocks part of the back of the sign and this particular sign is leaning over slightly as if it has been struck by something. This makes this sign less effective at helping to guide motorists and harder to be seen along the roadway. It was noted that this specific curve was the location of two (2) of the injury crashes which occurred along Wolfrum Road.

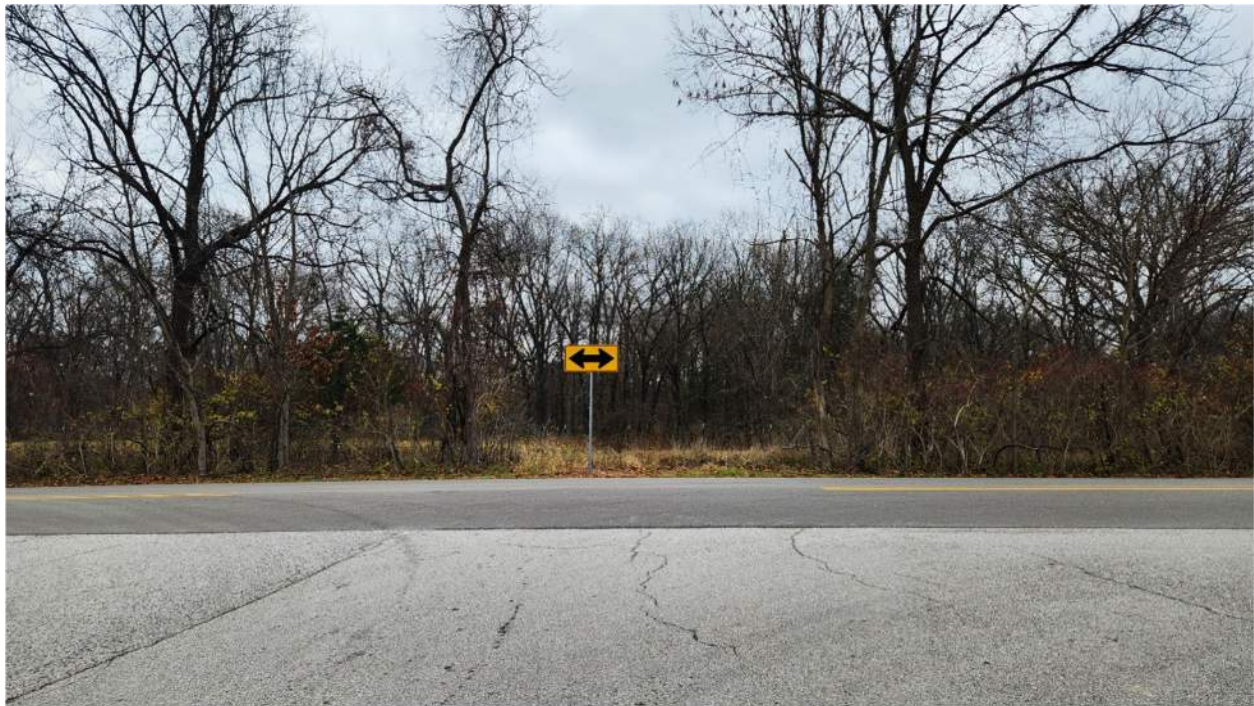
Figure 18 – Sign W1-7 at end of Patriotic Trail.

This sign is installed at the far side of a T-intersection in line with the view of traffic coming from the stem of the T-intersection. The standard size of this sign is to be 48 inches wide by 24 inches in height, which appears to be the size installed, however larger versions of this sign can be 60 inches wide by 30 inches tall to make the sign more noticeable to drivers. With the gap in the trees which may not indicate the end of the roadway, it might be advisable to install a larger sign at this location if crashes become an issue with vehicles not navigating the turn successfully.

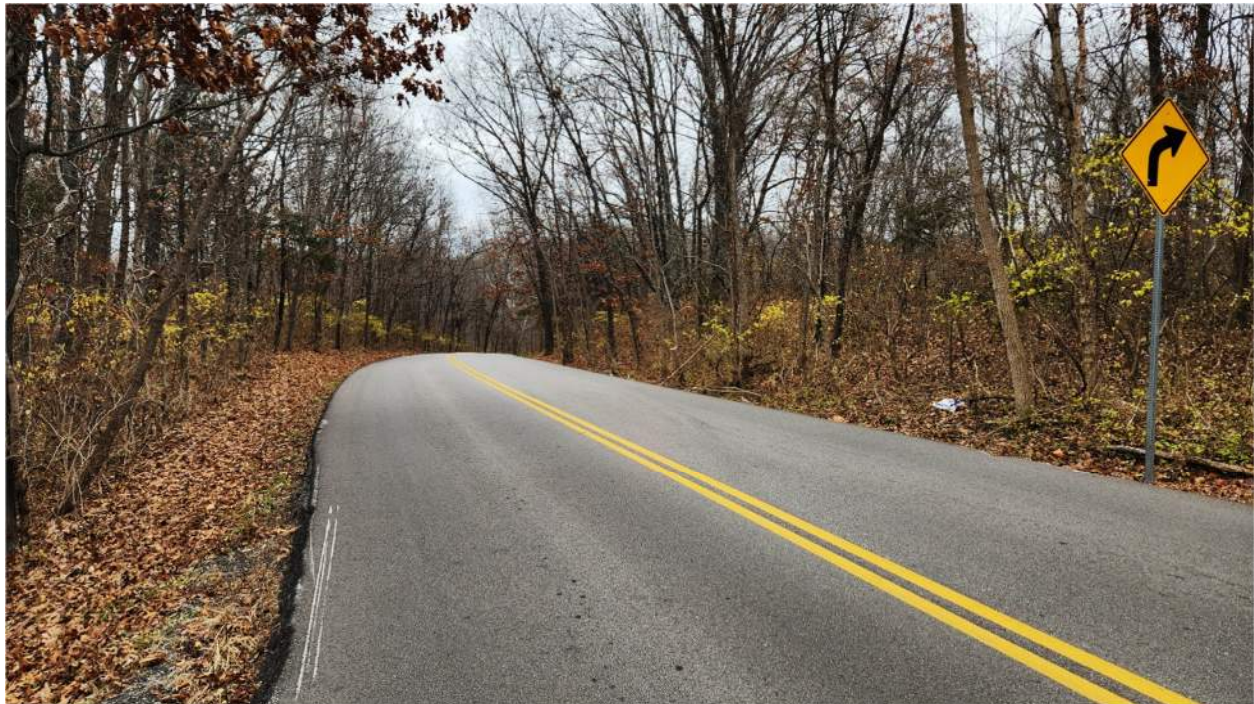
Figure 19 - W1-2 curve sign prior to steep downhill grade.

Coming over the crest of this hill and around the curve it is difficult to see anything that might be around the corner and with the estimated 15.5% downhill grade the lack of sight distance and grade make it more difficult to stop, especially on wet or icy pavement. This may lead to the suggestion of providing additional advisory or warning signs to warn westbound drivers.

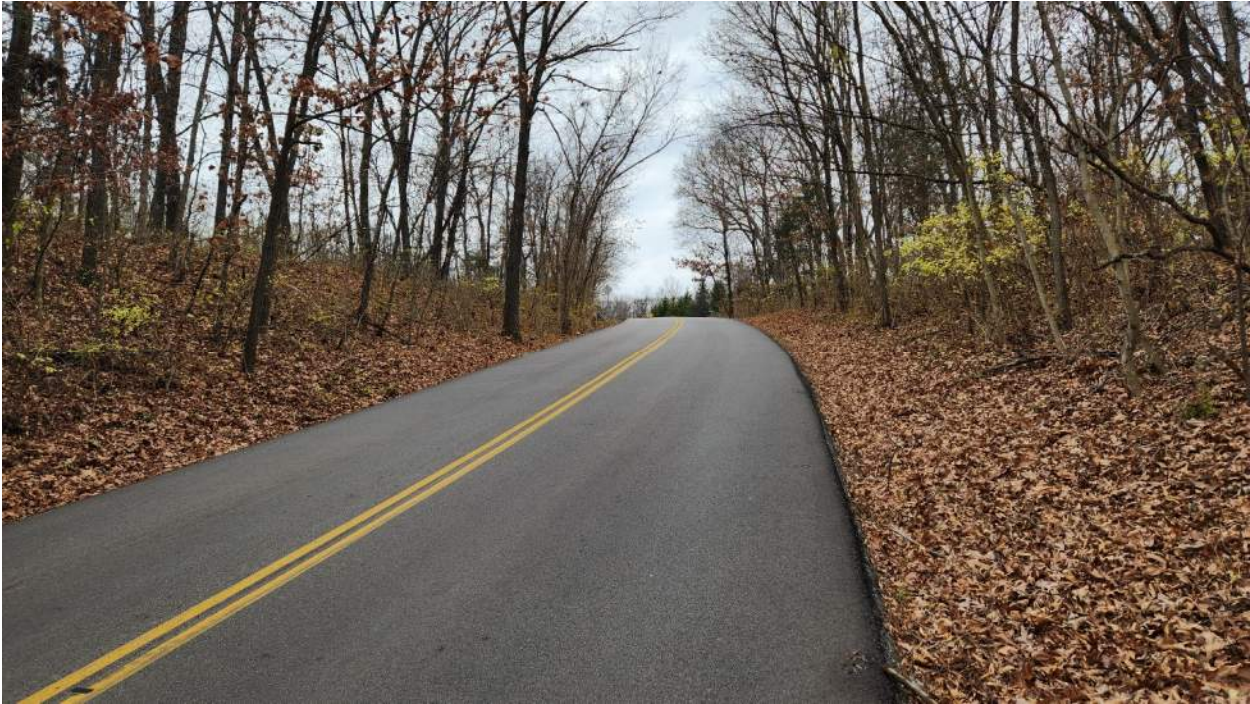
To provide an idea of the slope of the roadway Figure 20 shows the view looking back to the east up the hill toward this initial curve from a point partially down the hill. It was also noted in this section while observing the signage that there is a significant drop-off at the pavement edges on both sides of the roadway.

Figure 20 - View looking east back uphill at the curve.

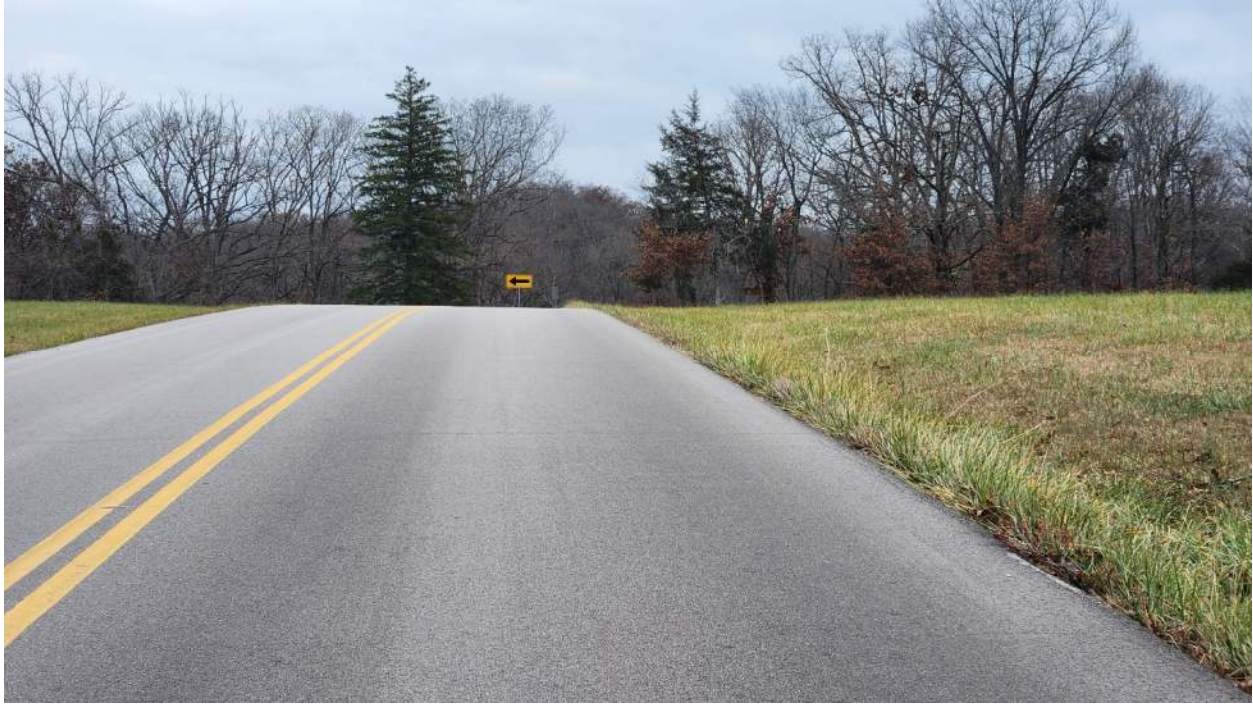
The next location with numerous crashes which likely needs additional signing is near the Strathalbyn Farms and Old Wolfrum Road intersection where Wolfrum road makes a 90-degree curve before continuing in a north-south direction. Vehicles approaching the curve from the west are coming uphill toward the curve and there is a slight crest vertical curve which hides the sharp curvature. A view of the sightline for the driver approaching the curve is shown in Figure 21. From the photo taken, the W1-6 sign is visible in the distance, but the curve itself is not visible at this distance.

At this location there is no advance warning sign when traveling westbound, although it appears that there was an advance warning sign back in May of 2019 in Google Streetview. If this sign was struck by a vehicle leaving the roadway, it was never replaced. The W1-1 sign which had been in place had an advisory plaque (W13-1P) which had a recommended speed of 20 mph.

Figure 21 - View approaching the 90-degree curve at Strathalbyn Road.

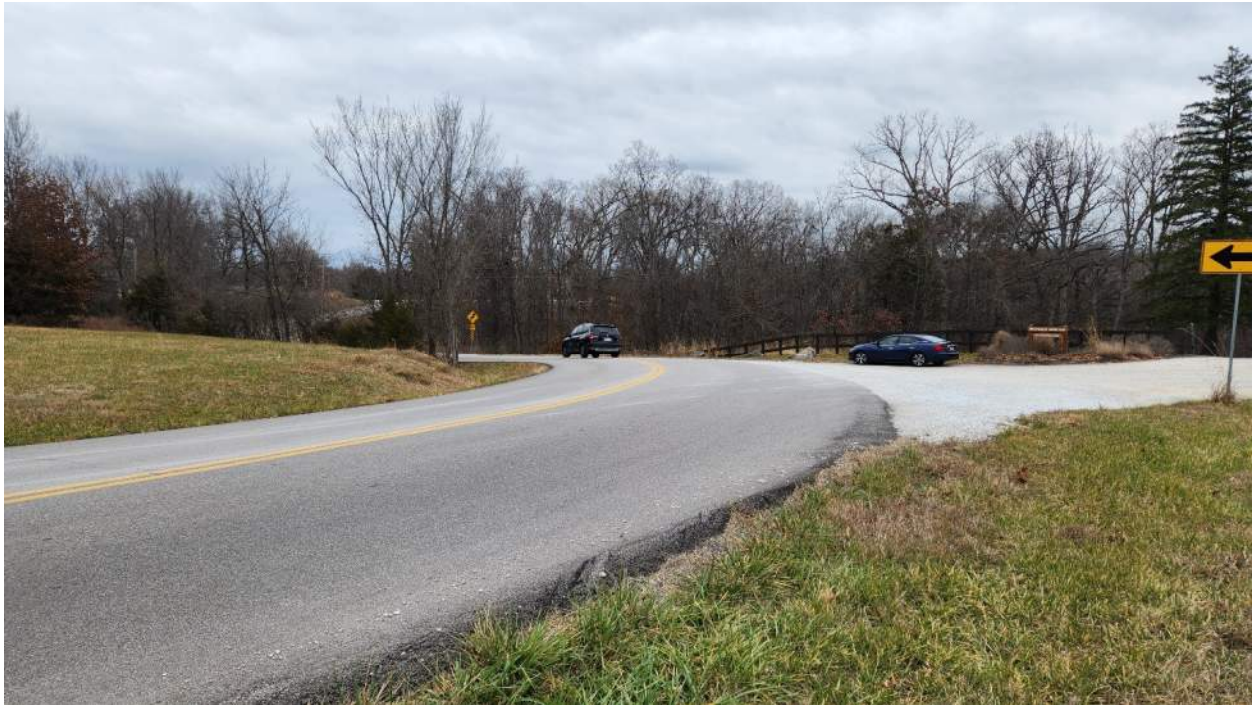
As shown in Figure 22, the curve is sharp to remain on Wolfrum Road and there is a gravel shoulder that leads to Strathalbyn Farms and Old Wolfrum Road which is positioned lower than the existing pavement and has a sloped drop-off. This could cause some instability to cars rounding the corner which have a tire leave the pavement, but is not as severe as some drop-offs located along the length of the roadway.

Figure 22 - Curve at the Strathalbyn Farm intersection.

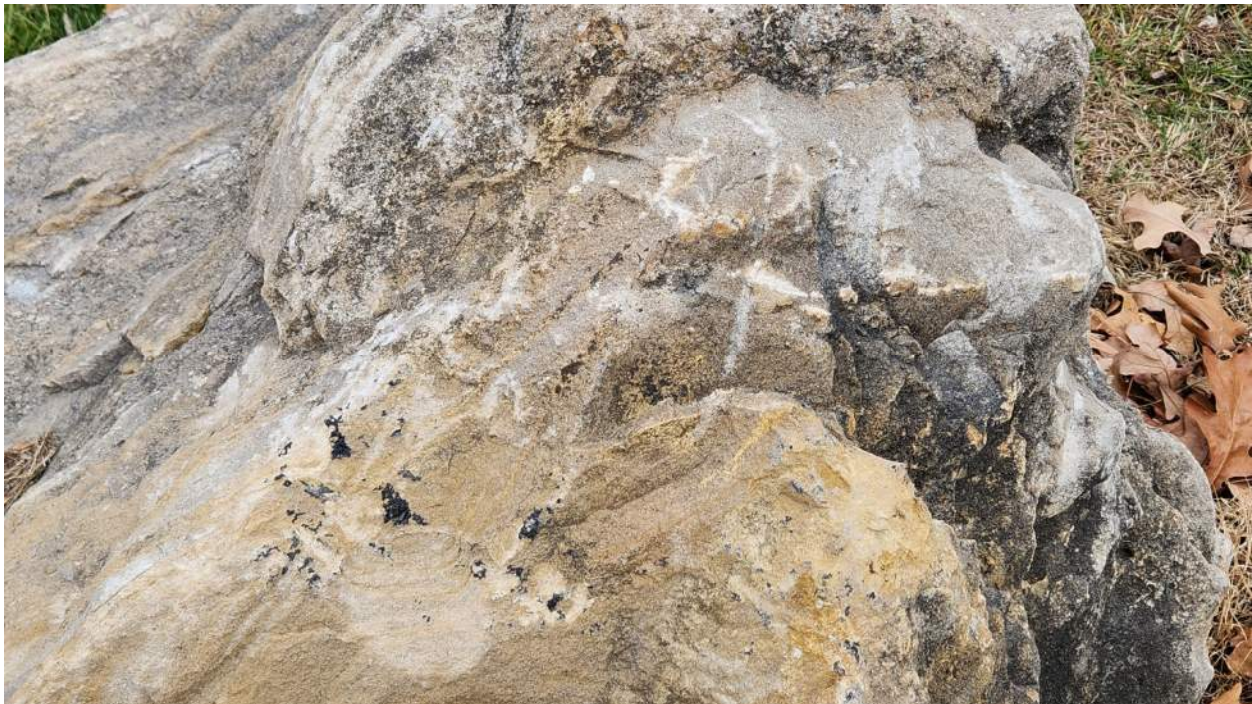
At this sharp curve there are numerous visible signs that cars have difficulty navigating the corner which may be surprising to unfamiliar drivers or hard to navigate on wet or icy pavement or at higher speeds. The Strathalbyn Farms Gun Club has placed large boulders on the far side of the curve as protection for their fence line which appears to have been replaced in sections due to previous damage. The boulders themselves show scrapes and paint marks from being struck by errant vehicles which have gone off the roadway. This is shown in Figure 23. A review of the crash reports and data from this location show that multiple injury crashes have occurred in the area with vehicles leaving the roadway surface due to being unable to successfully navigate the curve.

Figure 23 - Damaged boulder with scrapes and paint transfer.

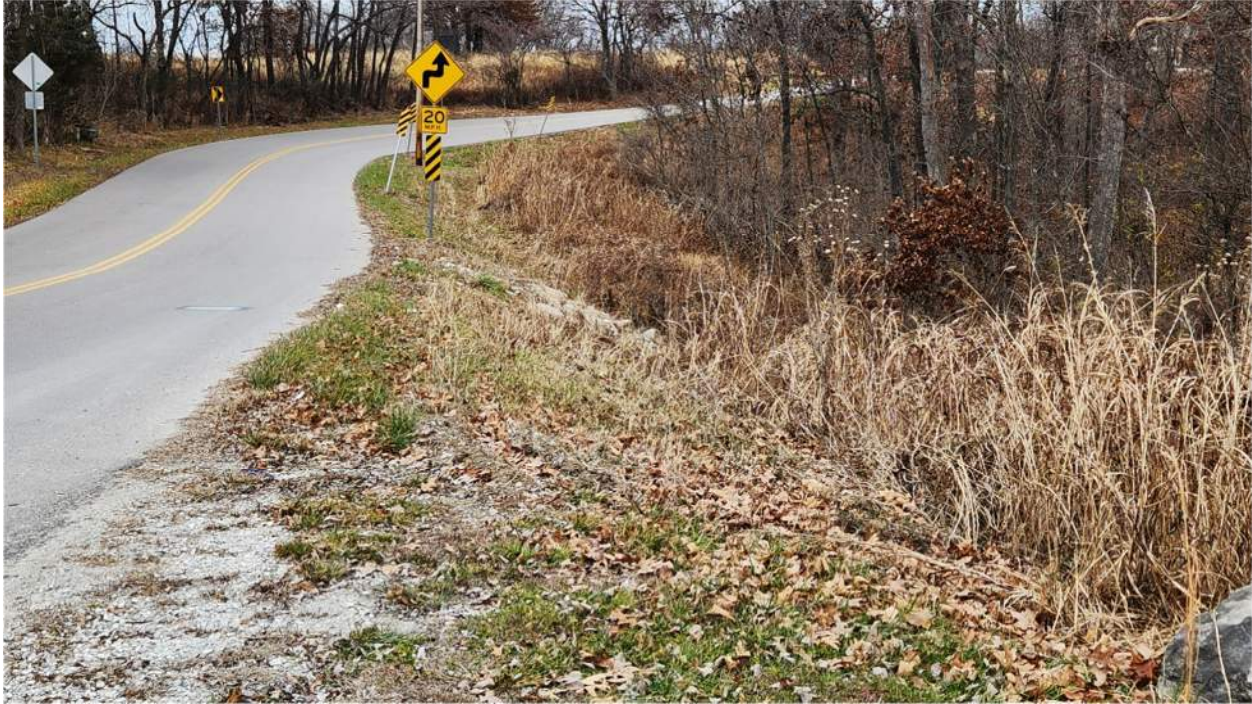
After rounding the 90-degree curve to the left the driver is presented with a reverse curve to the right and then back to the left with an advisory speed of 20 mph. This section of roadway has the W1-3 sign denoting the reverse curve with the advisory plaque, several chevron (W1-8) signs and several Type 3 object marker signs to designate the steep drop off along the side of the roadway. This location is shown in Figure 24.

The object markers were in place to denote the steep drop which also contains a drainage structure and outfall along the side of the roadway partially down the slope from the edge of pavement. It was noted that several of these signs are leaning to the side, implying they have been clipped by vehicles traveling around the curve along Wolfrum. Additionally, there are chevron signs for the opposite direction of travel which have the back side facing the eastbound/northbound traffic.

Figure 24 - Signage denoting reverse curve north of Starthalbyn Dr.

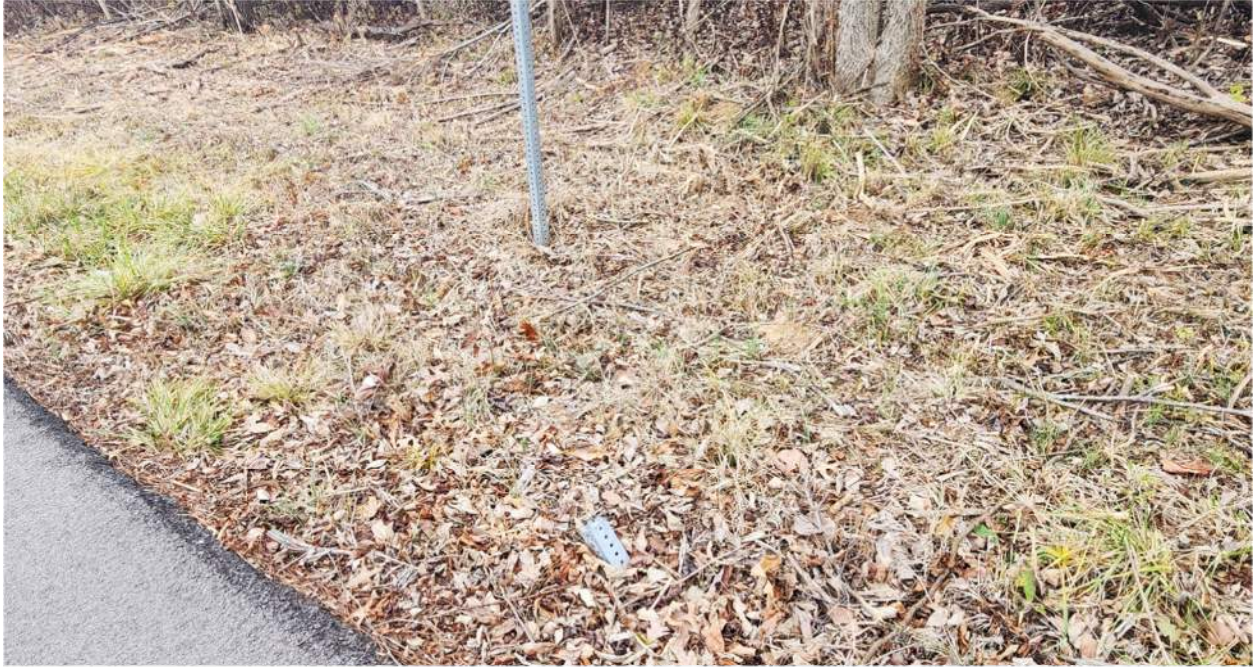
Figure 25 - Broken sign post foundation.

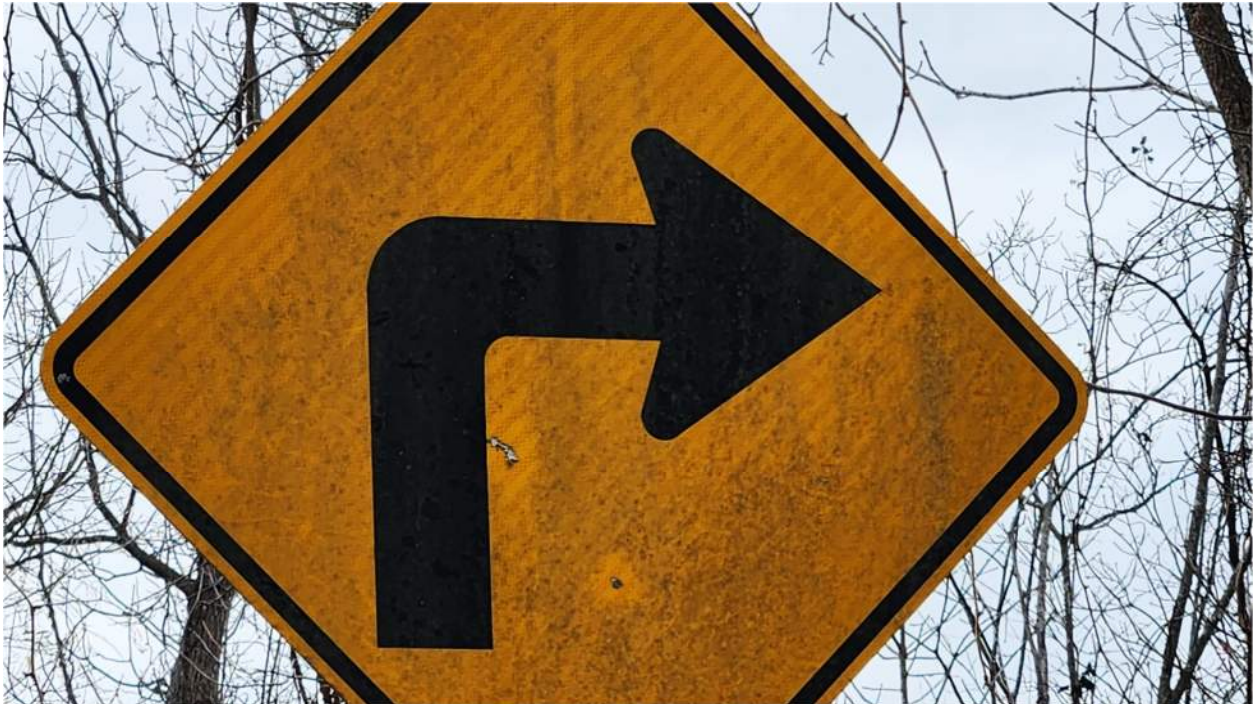
In the opposite direction of travel, heading south and west along Wolfrum Road, it was noted that there is a curve advisory sign (W1-1) with a speed advisory plaque at the 90-degree curve. Upon closer investigation, it was also noted that there may have been another version of this sign or another type of sign placed near which had been struck and knocked down as the base of the sign post was still visible in the ground as shown in Figure 25. The sign that remains also appears to be darkened and obscured with dirt and a dark residue of some type on the sign. This dirt reduces the retroreflectivity of the sign when viewed and especially at night when headlights are supposed to illuminate the sign. This may make it harder to see and reduces the effectiveness of warning motorists about the upcoming curve, although after having just navigated the reverse curve section drivers have hopefully already slowed their speed entering the 90-degree curve. The less reflective sign is shown in Figure 26.

Figure 26 - Dirty sign with reduced retroreflectivity at night.

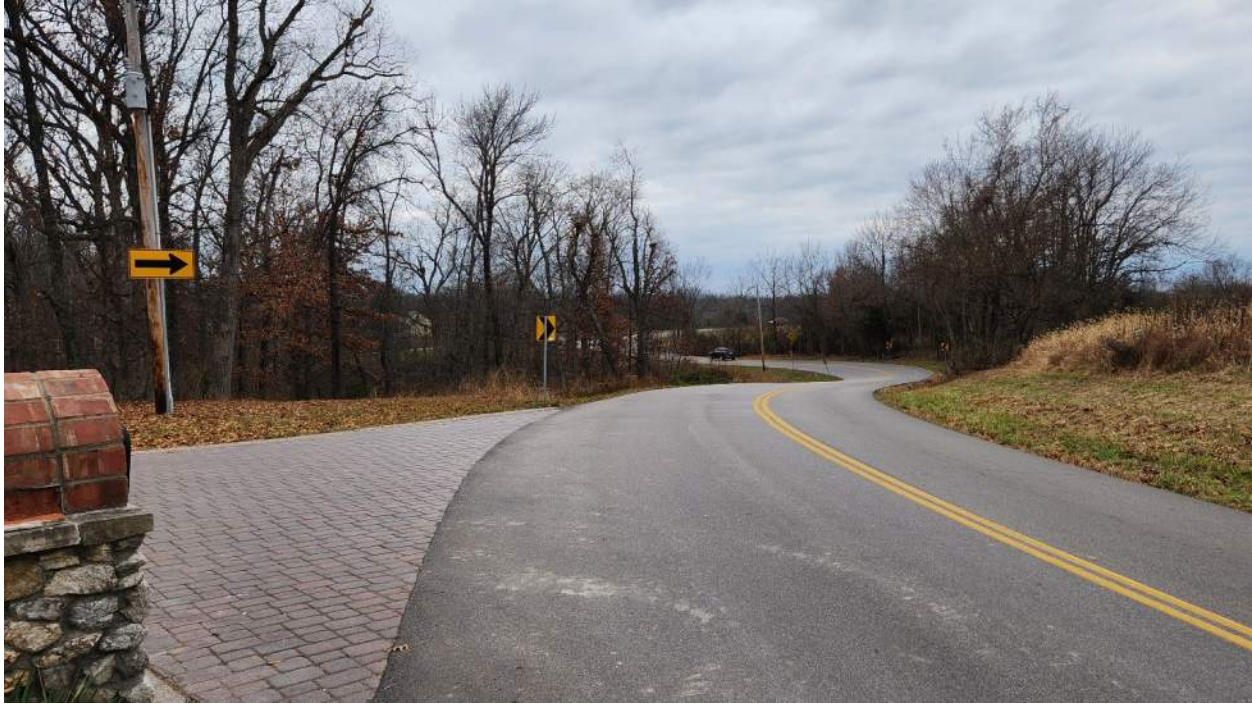
Moving along the curve to the north and looking back toward the Strathalbyn Rd intersection to the south, drivers can see the reverse curves in Figure 27. Heading southbound toward the intersection, there is a W1-6 sign which denotes the first curve and again there is an uphill stretch leading into the curve which makes it hard to see for drivers approaching the curve. There is an advance warning sign of the upcoming reverse curve heading southbound (W1-3) with a speed advisory plaque of 20 mph. There is also a small horse crossing sign posted on the bottom of the sign which does not appear to meet the minimum size criteria for the official crossing sign per the MUTCD. These conditions on the approach can be seen in Figure 28.

Figure 27 - Reverse curves looking to the south along Wolfrum Road.

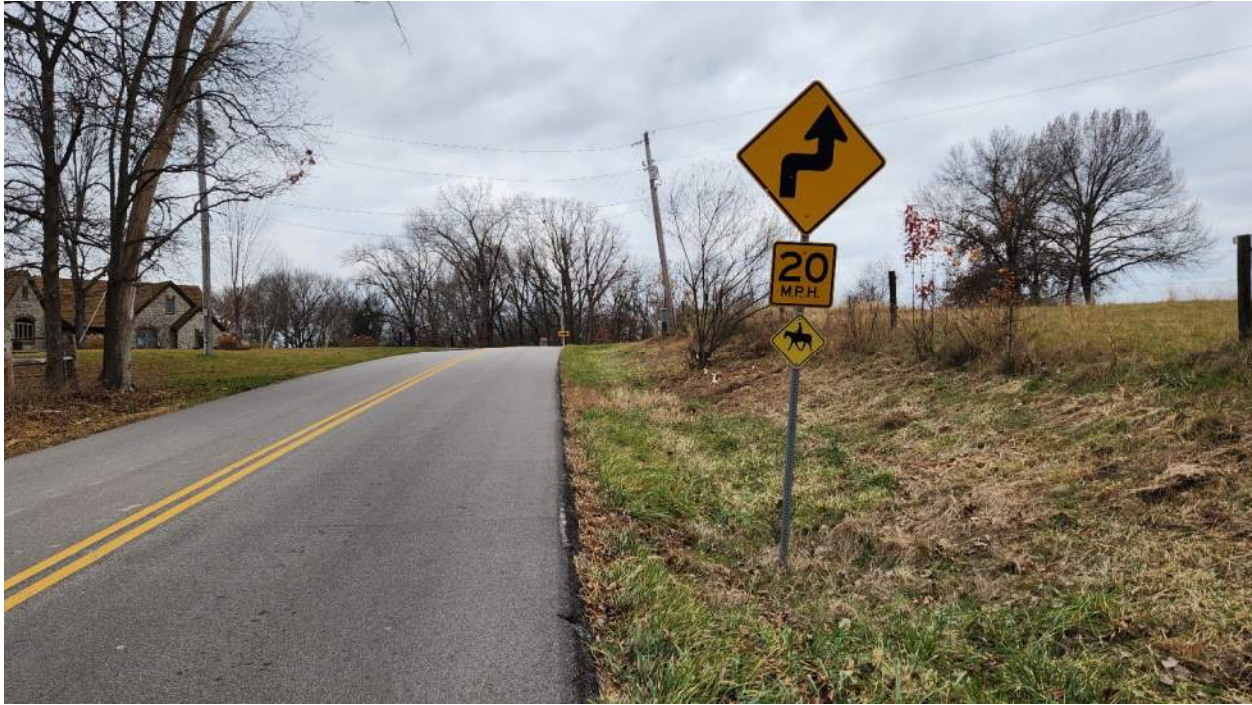
Figure 28 - Advance curve warning sign and approach to first turn heading southbound.

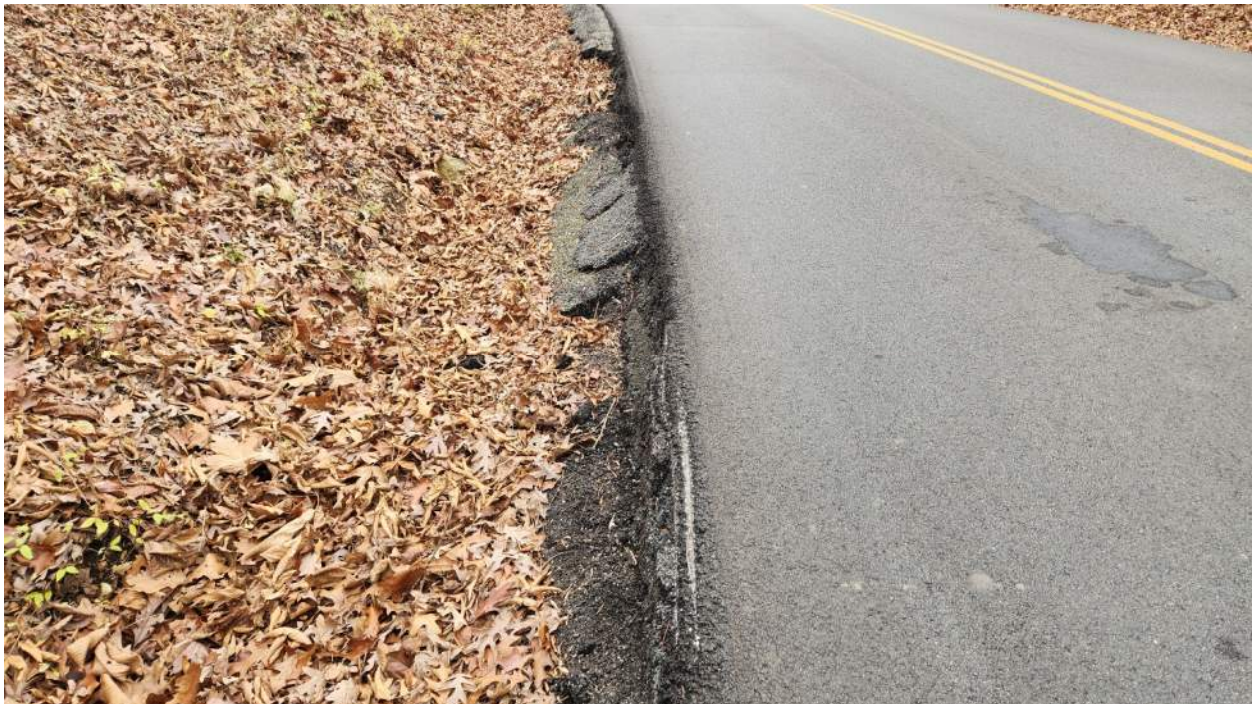
The City of Weldon Spring has discussed with TERRA that the pavement has been overlaid multiple times with new asphalt which has raised the top of pavement elevation, however the elevation of the ground adjacent to the pavement was not necessarily raised along with the pavement height. With no shoulders or safety edge along the outside edge, when a tire goes off of the edge of pavement there is a drop almost straight down which often leads to

the frame of the car scraping on the edge of pavement and provides no room for the driver to recover their vehicle because the tire may be in the air or has nothing to gain traction on. It was noted in reading the crash reports that a number of vehicles did have a tire go off the right edge of pavement and then turned the steering wheel to the left to try to get back onto the pavement which resulted in them losing control of the vehicle, crossing the centerline and leaving the left side of the pavement. An example of one drop-off observed is shown in Figure 29. As shown in the photo there are numerous scrape marks along the edge of the pavement from vehicle frames hitting the edge and the asphalt edge has broken off the edge in some places.

Figure 29 - Pavement edge drop-off east of Patriotic Trail

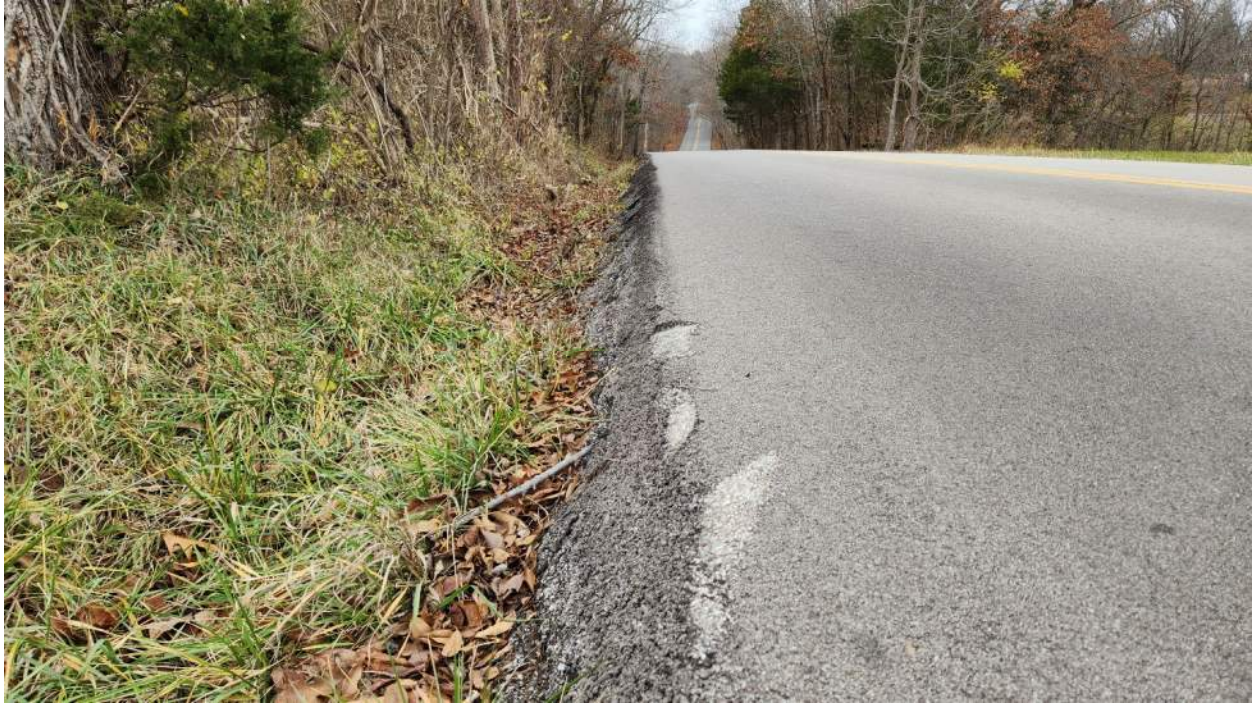
Further down the roadway it was noted that there were similar edge drop-off concerns at the edge of pavement throughout the length of the corridor. Another example from the area near Strathalbyn Farms is provided in Figure 30. Again, there are numerous scrapes observed on the edge of pavement near the lane in this area and the drop-off from the edge of pavement is severe, as is typical throughout the length of Wolfrum Road. This edge drop-off makes it very difficult for vehicles going off the road to recover back onto the pavement should they have a wheel go over the edge. This may mean that some types of edge treatments such as rumble stripes, narrow shoulders or some other treatment might need to be considered to improve safety throughout the study area.

Figure 30 - Another edge drop-off near Strathalbyn Farms
