TERRA
ENGINEERING LTD.

CITY OF WELDON SPRING

“BACK” WOLFRUM ROAD SAFETY STUDY

December 14, 2023

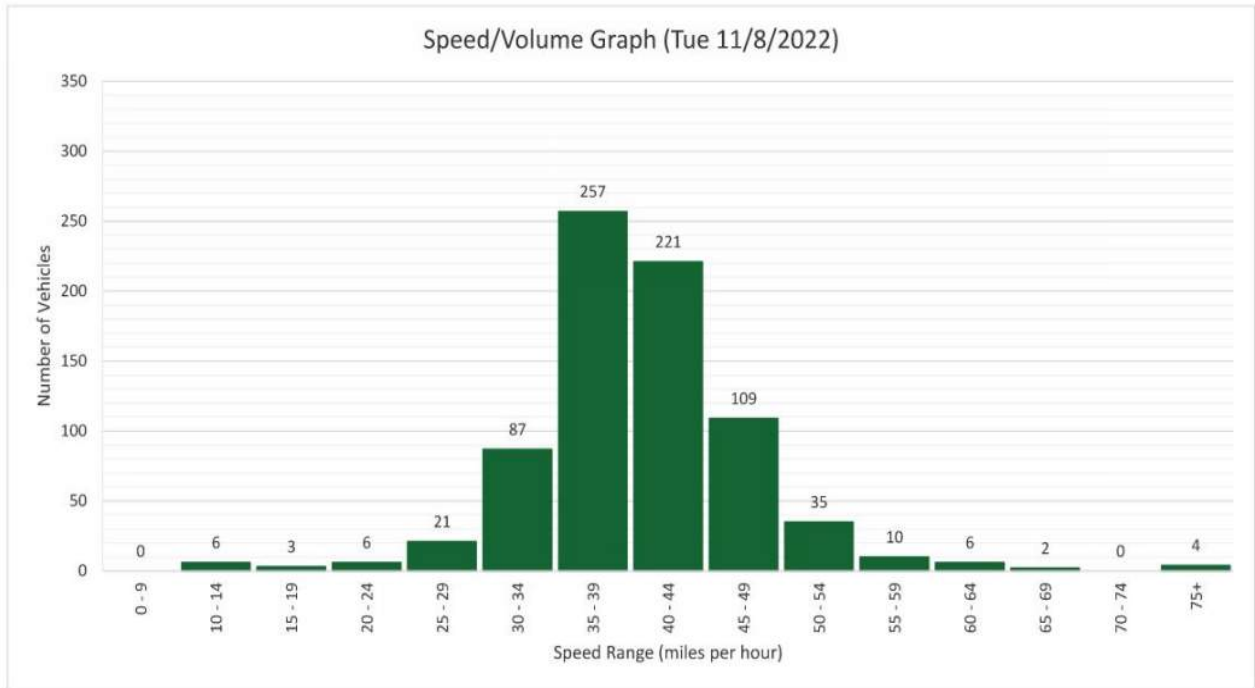
Figure 1 - Speed and volume data for 11/08/2022.

In reviewing the figures, it shows that a majority of the vehicles on each day of observation appear to be traveling within the bars which represent the speeds of 35-45 mph. However, it is also noted that 100-150 vehicles per day are travelling between 45-49 mph which is greater each day than those traveling between 30 mph and 34 mph. Finally, it was observed that around 40 per day are between 50-55 mph, which is an excessive speed for a roadway with approximately 10-11' foot lanes with no shoulders and significant drop-offs at the edge of pavement.

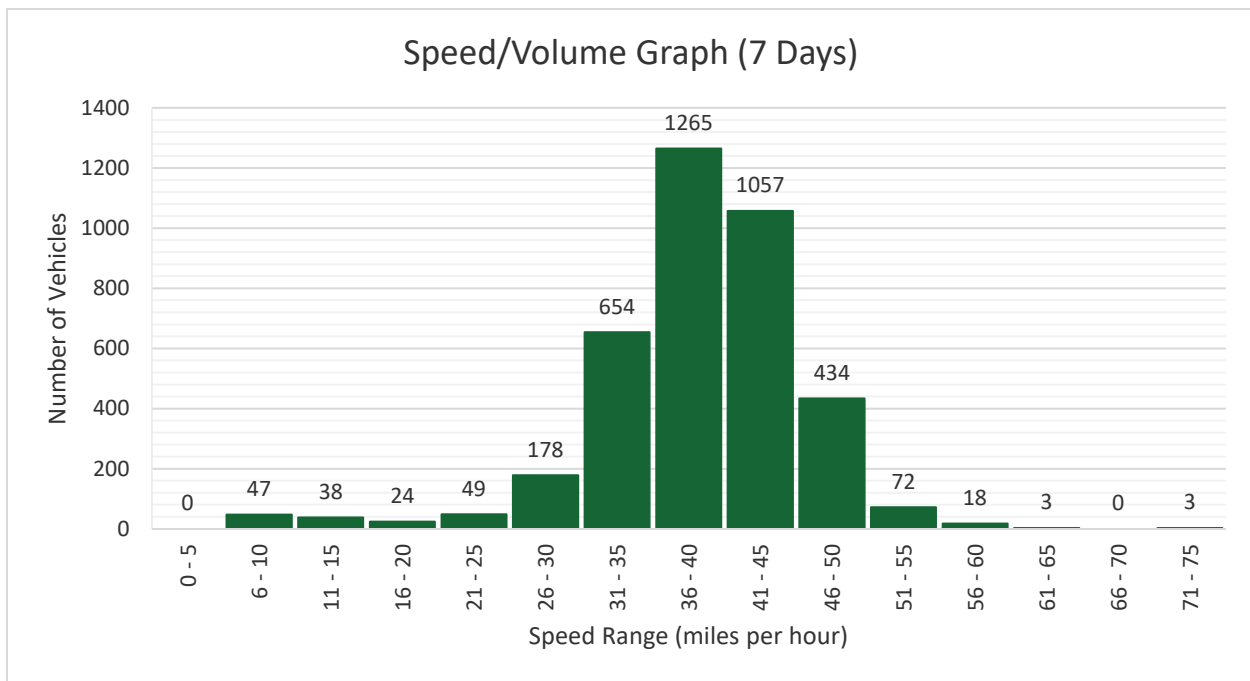
Figure 11 - Speed/Volume graph for entire 7-day data collection duration.

From the data provided by Weldon Springs, 74% of vehicles traveled faster than the speed limit of 35 mph, 41% traveled faster than 40 mph, and 14% traveled faster than 45 mph.

The distribution of the graphs is similar to what TERRA’s counts observed with the bulk of the vehicles traveling between 35-45 mph, but a significant number of vehicles traveling in the 45-55 mph range. Although the totals show a higher percentage of drivers in the 31-35 mph range than in the TERRA count, which may be due to the feedback from the radar-controlled speed readout which shows drivers their speed or the location of the count.

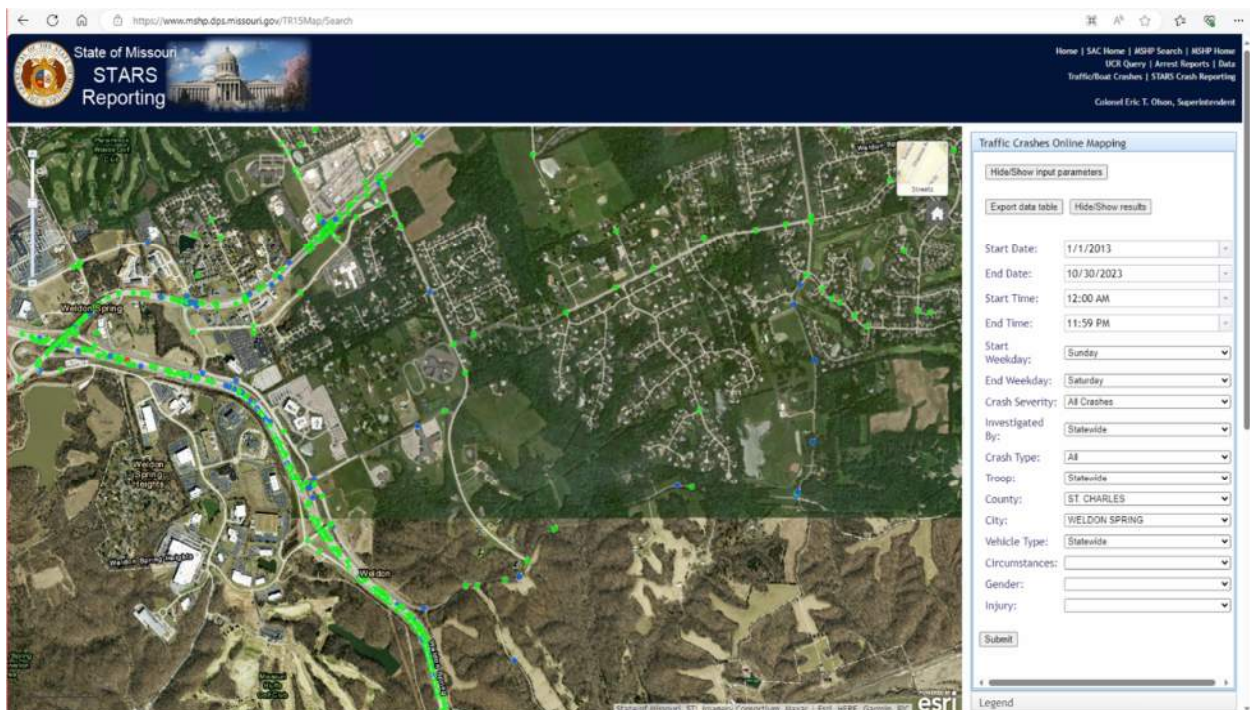
Figure 12 - Screenshot of Crash Query from MSHP website.

The website allows the user to input the parameters for a specific request within the system to return search results tailored to meet their query. The request submitted by TERRA included the dates of January 1, 2013, through October 30, 2023, to provide the last 10 years of available data. The website containing the crash data is available at www.mshp.dps.missouri.gov/TR15Map/Search. A map showing the query and the crashes within the immediate area of Wolfrum Road is shown in Figure 12.

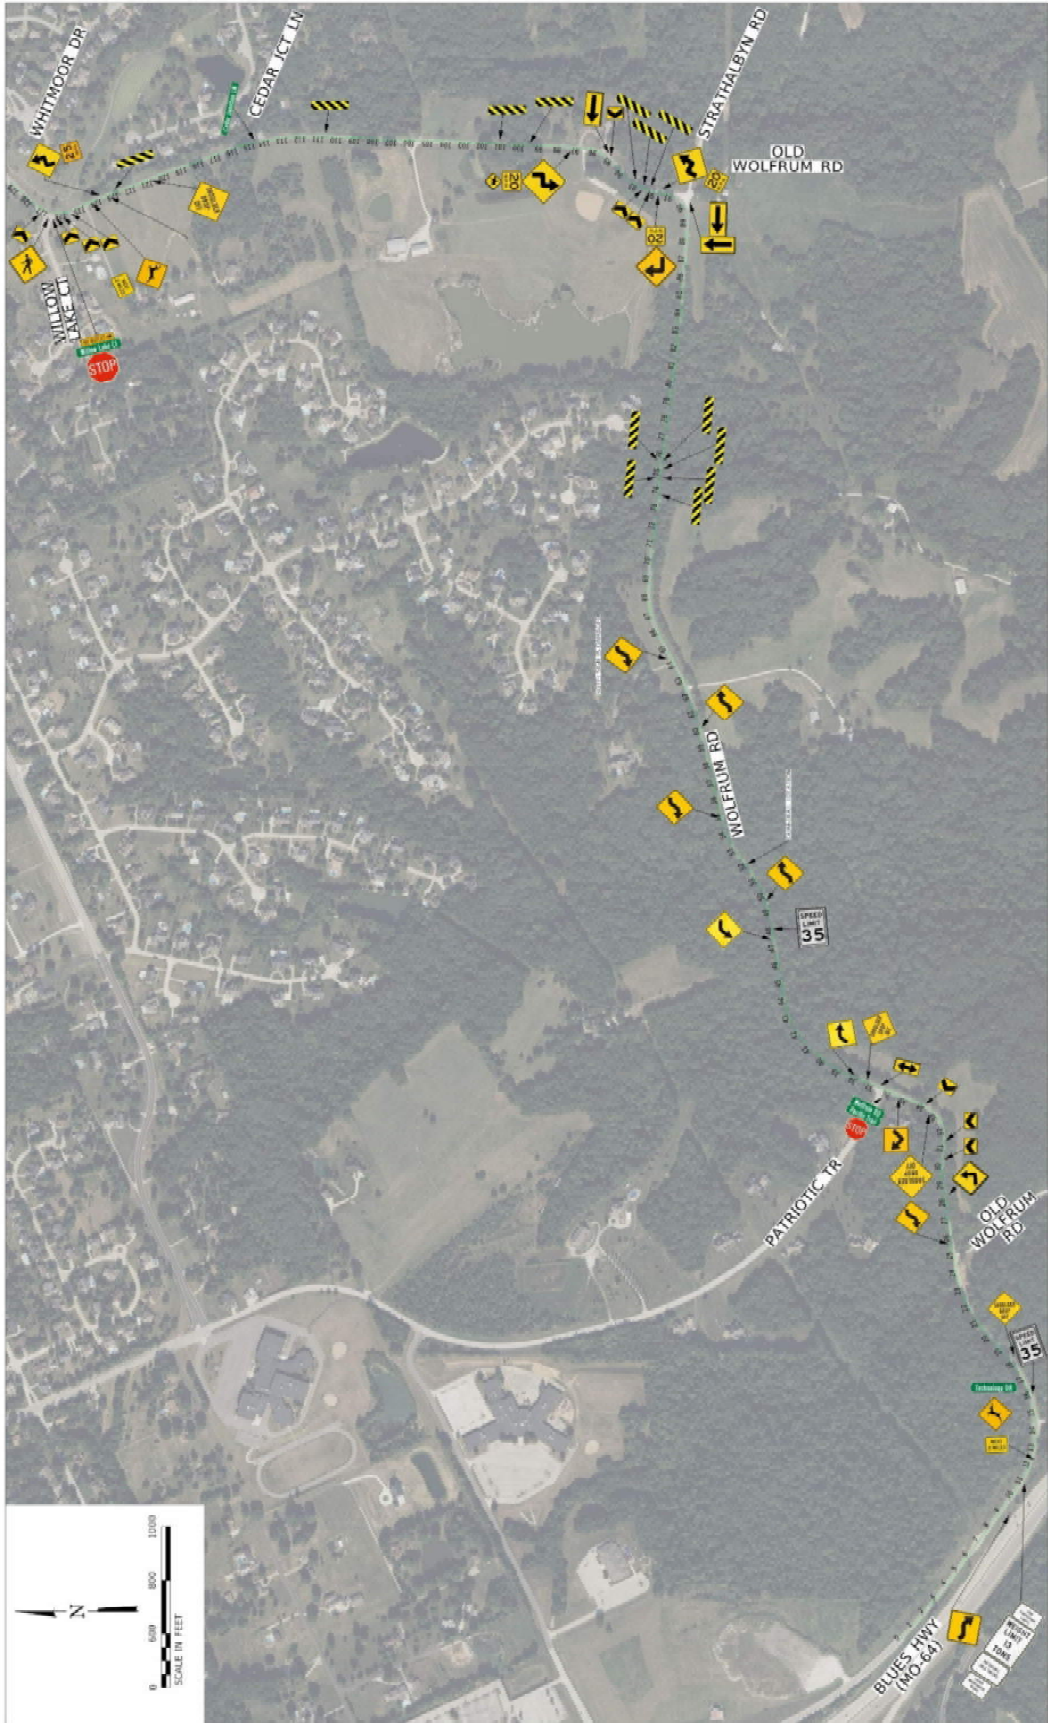
Existing Signage Exhibit
DRAFT 12/11/2023

Several items were noted in the field review of the sign conditions and the signing locations. The first thing noted was the number of signs which were damaged or missing.
